Report on the breaking of a girth-hitched sling, with recommendations for usage of connected slings

Conducted by Mammut Sports Group, Seon, Switzerland. 1/10/2007

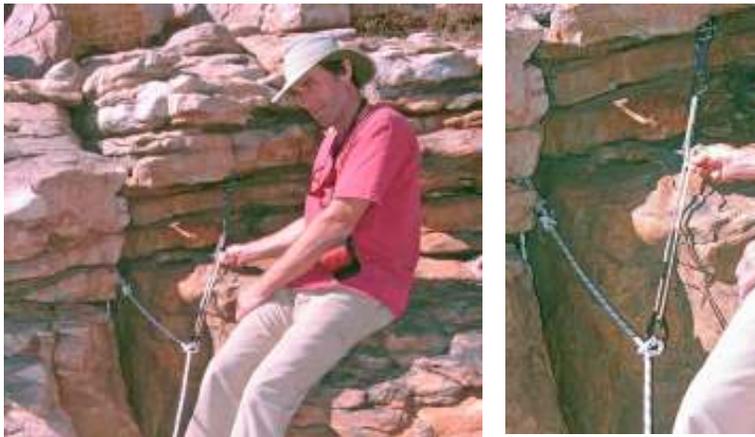
Fig. 1. The anchor in question on 10/22/06, showing the configuration of the slings

Because the secondary anchor containing the girth-hitched 8mm Contact sling was directly loaded, depending on the direction of load this would have taken the majority of the load. Because the rope was still attached to the main anchor component, Sherman was unhurt when the sling broke. Figure 2 shows photos of the broken sling at the site of the accident.

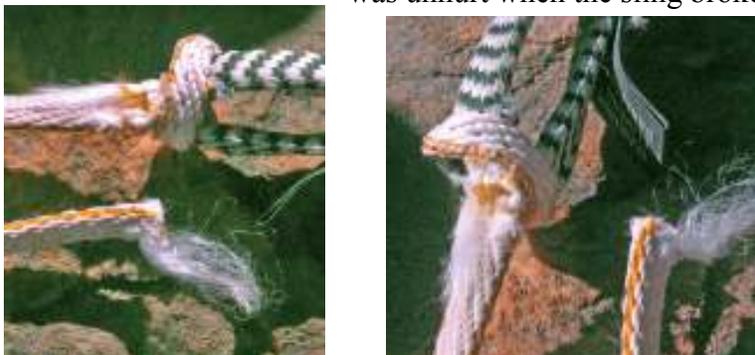
Fig. 2. Photos of the break taken at the site of the accident

The break of the Mammut sling is exactly located just outside the girth hitch. One strand of the sling is completely broken, while only a few threads on the other strand are damaged. In addition, there is a small area of damage on the spectra sling above the girth-hitch. Because the breaks resulting from loading a sling to failure have never shown this linear of a break, Mammut was very interested in obtaining the sling to do further analysis into the break.

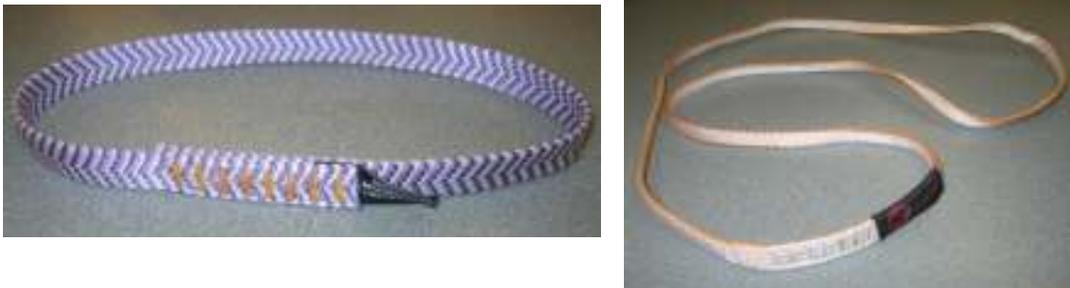
Fig. 3. Misty Mountain 15mm Spectra sling, strength 3097.5 DaN; and Mammut 8mm Contact sling, strength 2308DaN.

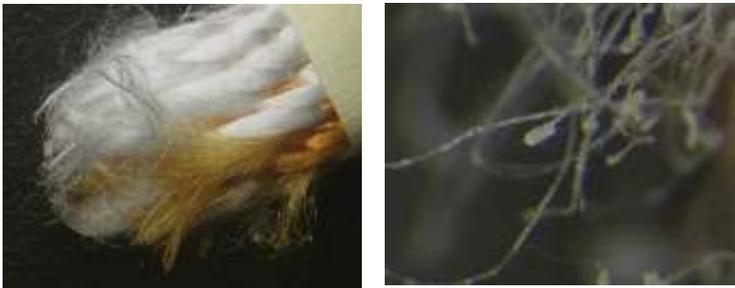
Fig. 8. A picture of a typical break produced by a static pull. Note the uneven nature of the break and the melted ends and melted together areas of the individual fibers

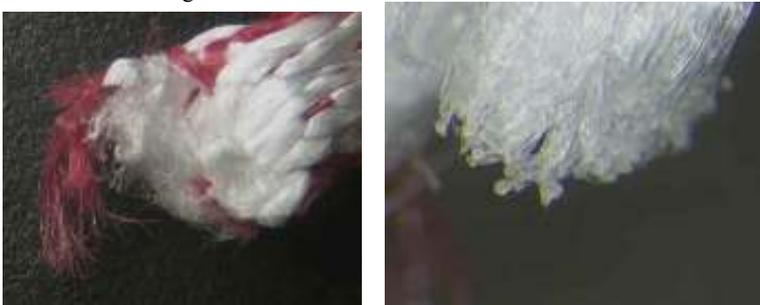
Fig 9. A typical dynamic break in a pretightened girth hitch. Note the long, extended nature of the break with clearly melted-together fibers

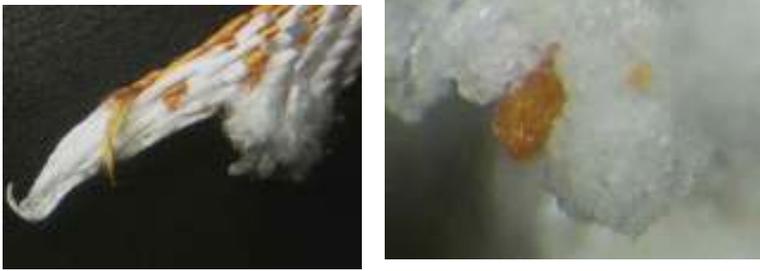
Fig. 10. A typical sling cut under an 800 DaN load. Note the even, but slightly diffuse break and the lack of melting at the ends of the fibers

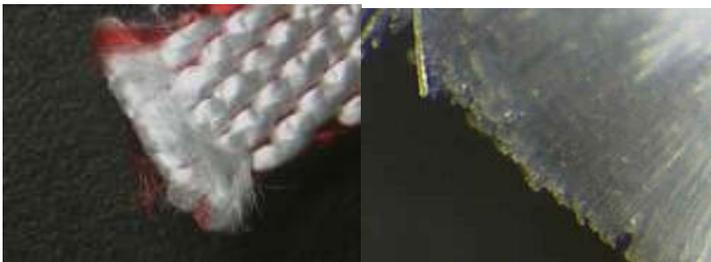
Fig. 11. A sling cut with no load. Note the very precise and straight break and the lack of melting at the ends of the fibers. The dark spots that appear to be melting are the ends of the nylon fibers seen head-on, which makes them appear darker

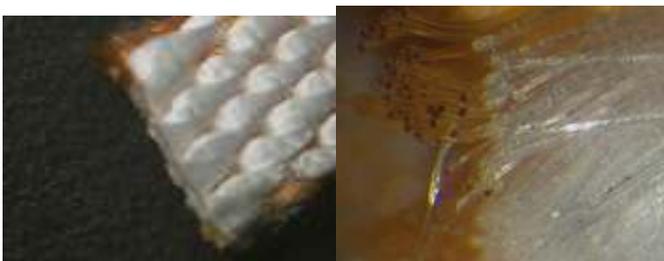
Fig. 12. A typical sling broken over a sharp edge. Note the uneven break and the melting of the ends and melted-together fibers

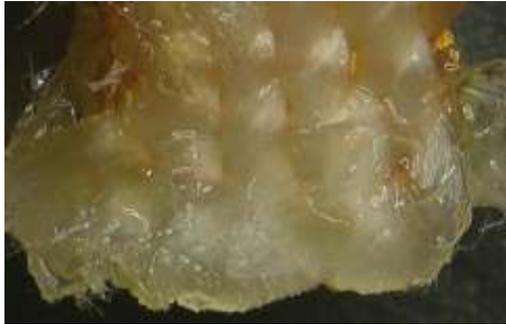
Fig 13

In addition, one photo (Fig. 13) was taken of a sling broken because of an acid contamination. Because the Sherman sling showed none of the deformation associated with this contamination, chemical analysis of the sling was considered unnecessary.

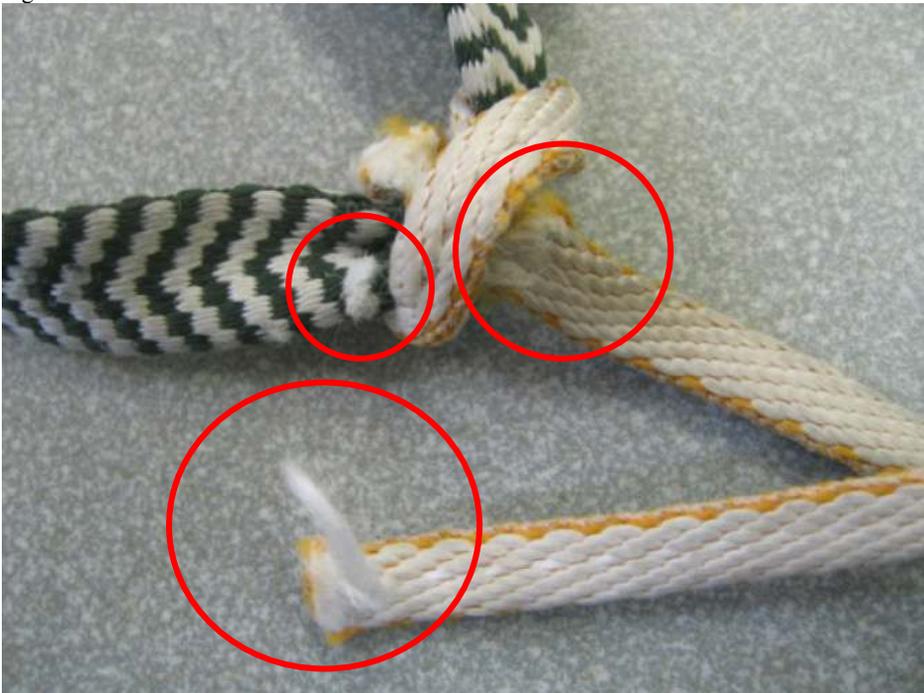
Fig 14a

The Sherman sling was also analyzed and photographed at the same time as the tested slings. In particular, three areas of the sling were looked at in detail, as shown in Fig 14a-14d.

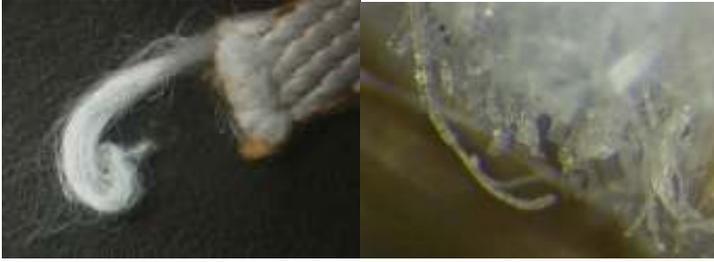
Fig 14b. Broken part of the sling. The break is diffuse, and clearly linear, with one pulled strand. There is no melting of the individual fibers visible.

The Sherman sling shows a linear break with one pulled fiber. There is no melting, or melting together, and the shot is not sheared. In addition, in all three of the damaged areas of the sling, the damage occurs outside the girth hitch, not inside as would be expected if the knot were the cause of the sling being weakened and damaged.

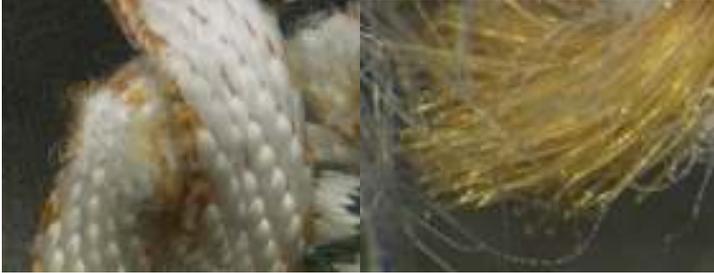
Fig 14c. Damaged part of the sling. Fibers on top of the sling are broken. There is no melting of the fibers.

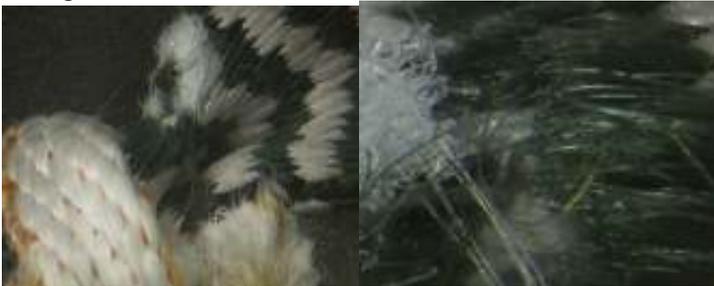
Fig 14d. Torn Spectra sling. The Spectra sling is torn about 0.5cm. The break has very linear characteristics, with no melting.

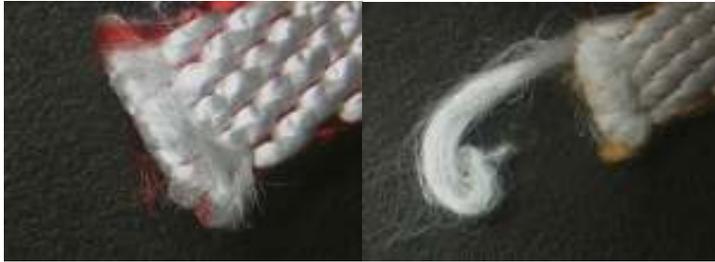
The biggest similarity to the breakage of the Sherman sling is the sling cut while under load (Fig. 15).

Both slings show a slightly diffuse, linear break and the individual fibers show no melting. The shot remains unscathed in both slings as well. The other damaged parts of the Sherman sling show linear characteristics and no melting as well, indicating a similar mechanism of damage.

In conclusion, as the testing shows and the previous literature on the subject supports, the strength of any slings that are connected with a knot can decrease over 50%. However, based on the fact that a UIAA certified sling holds at least 22kn (roughly 5000lbs), when girth hitched 880DaN or 2000lbs strength should remain. With normal human weight and under the described circumstances, this force could only have been reached with a multi-meter drop. Because of the lack of melting and the lack of similarity to any of the tested breaks, we do not believe the sling broke due to any force applied to it, even taking into consideration the weakening effect of the girth-hitch. The most plausible scenario, borne out by the linear characteristics of the break and location of the break outside the knot, is that the sling was cut with a very sharp object. The only difference is the pulled thread—it seems plausible that this thread could have been the only one not cut through and therefore it held the anchor in place so it appeared to be intact and finally pulled under a low load.

Climbers should be aware that all slings, whether skinny or fat, Dyneema/Spectra or Nylon, are susceptible to significant strength loss due to a girth hitch, and should use any connecting knots with caution. While there may be some additional strength loss when connecting skinnier slings, this additional loss is only a few percent (the equivalent of perhaps 250 lbs out of 5000)--the additional strength loss is not enough to treat today's extremely thin slings any differently than fatter or nylon slings—all girth hitches must be treated with caution. The safest way to obtain a longer sling is to use a longer sling in the first place, rather than connecting them at all. If two slings must be joined, the strongest way to do so is with a carabiner.
