Report on the breaking of a girth-hitched sling, with recommendations for usage of connected slings

Conducted by Mammut Sports Group, Seon, Switzerland. 1/10/2007

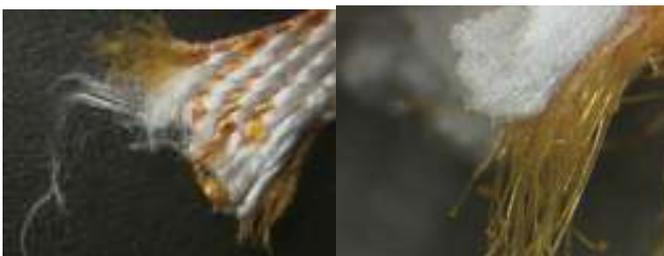
Fig. 12. A typical sling broken over a sharp edge. Note the uneven break and the melting of the ends and melted-together fibers
